# Manhole Inspection Summary

Manhole # S37Q\_\_046MH

**Inspection** ☐ Is Incomplete Rating: **3) Fair**

**Location** Address: **1100 Covington St**

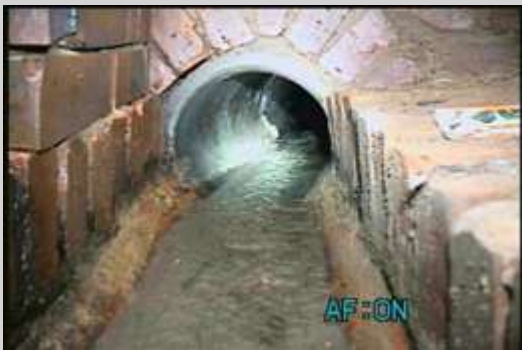
12 O'Clock Outflow

8 in. Circular Gravity Sewer  
Pipe Out @ 12 OClock

Invert Depth: 8.50 (ft.) Flow Characteristics: Fast

Deposits: ☒ None ☐ Mud ☐ Sludge ☐ Debris ☐ Grease

Infiltration: None Pipe Seal Cond: Unknown

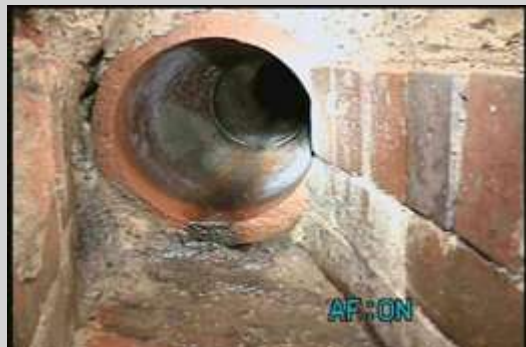
9 O'Clock Inflow

8 in. Circular Gravity Sewer  
Pipe In @ 9 O'Clock
